# Madsen Creek Flow and Water Quality Control Pond

## *Operations & Maintenance Manual*

September 2012

**Department of Natural Resources and Parks**  
Water and Land Resources Division  
Stormwater Services Section, Capital Services Unit  
201 South Jackson Street, Suite 600  
Seattle, Washington 98104-3855

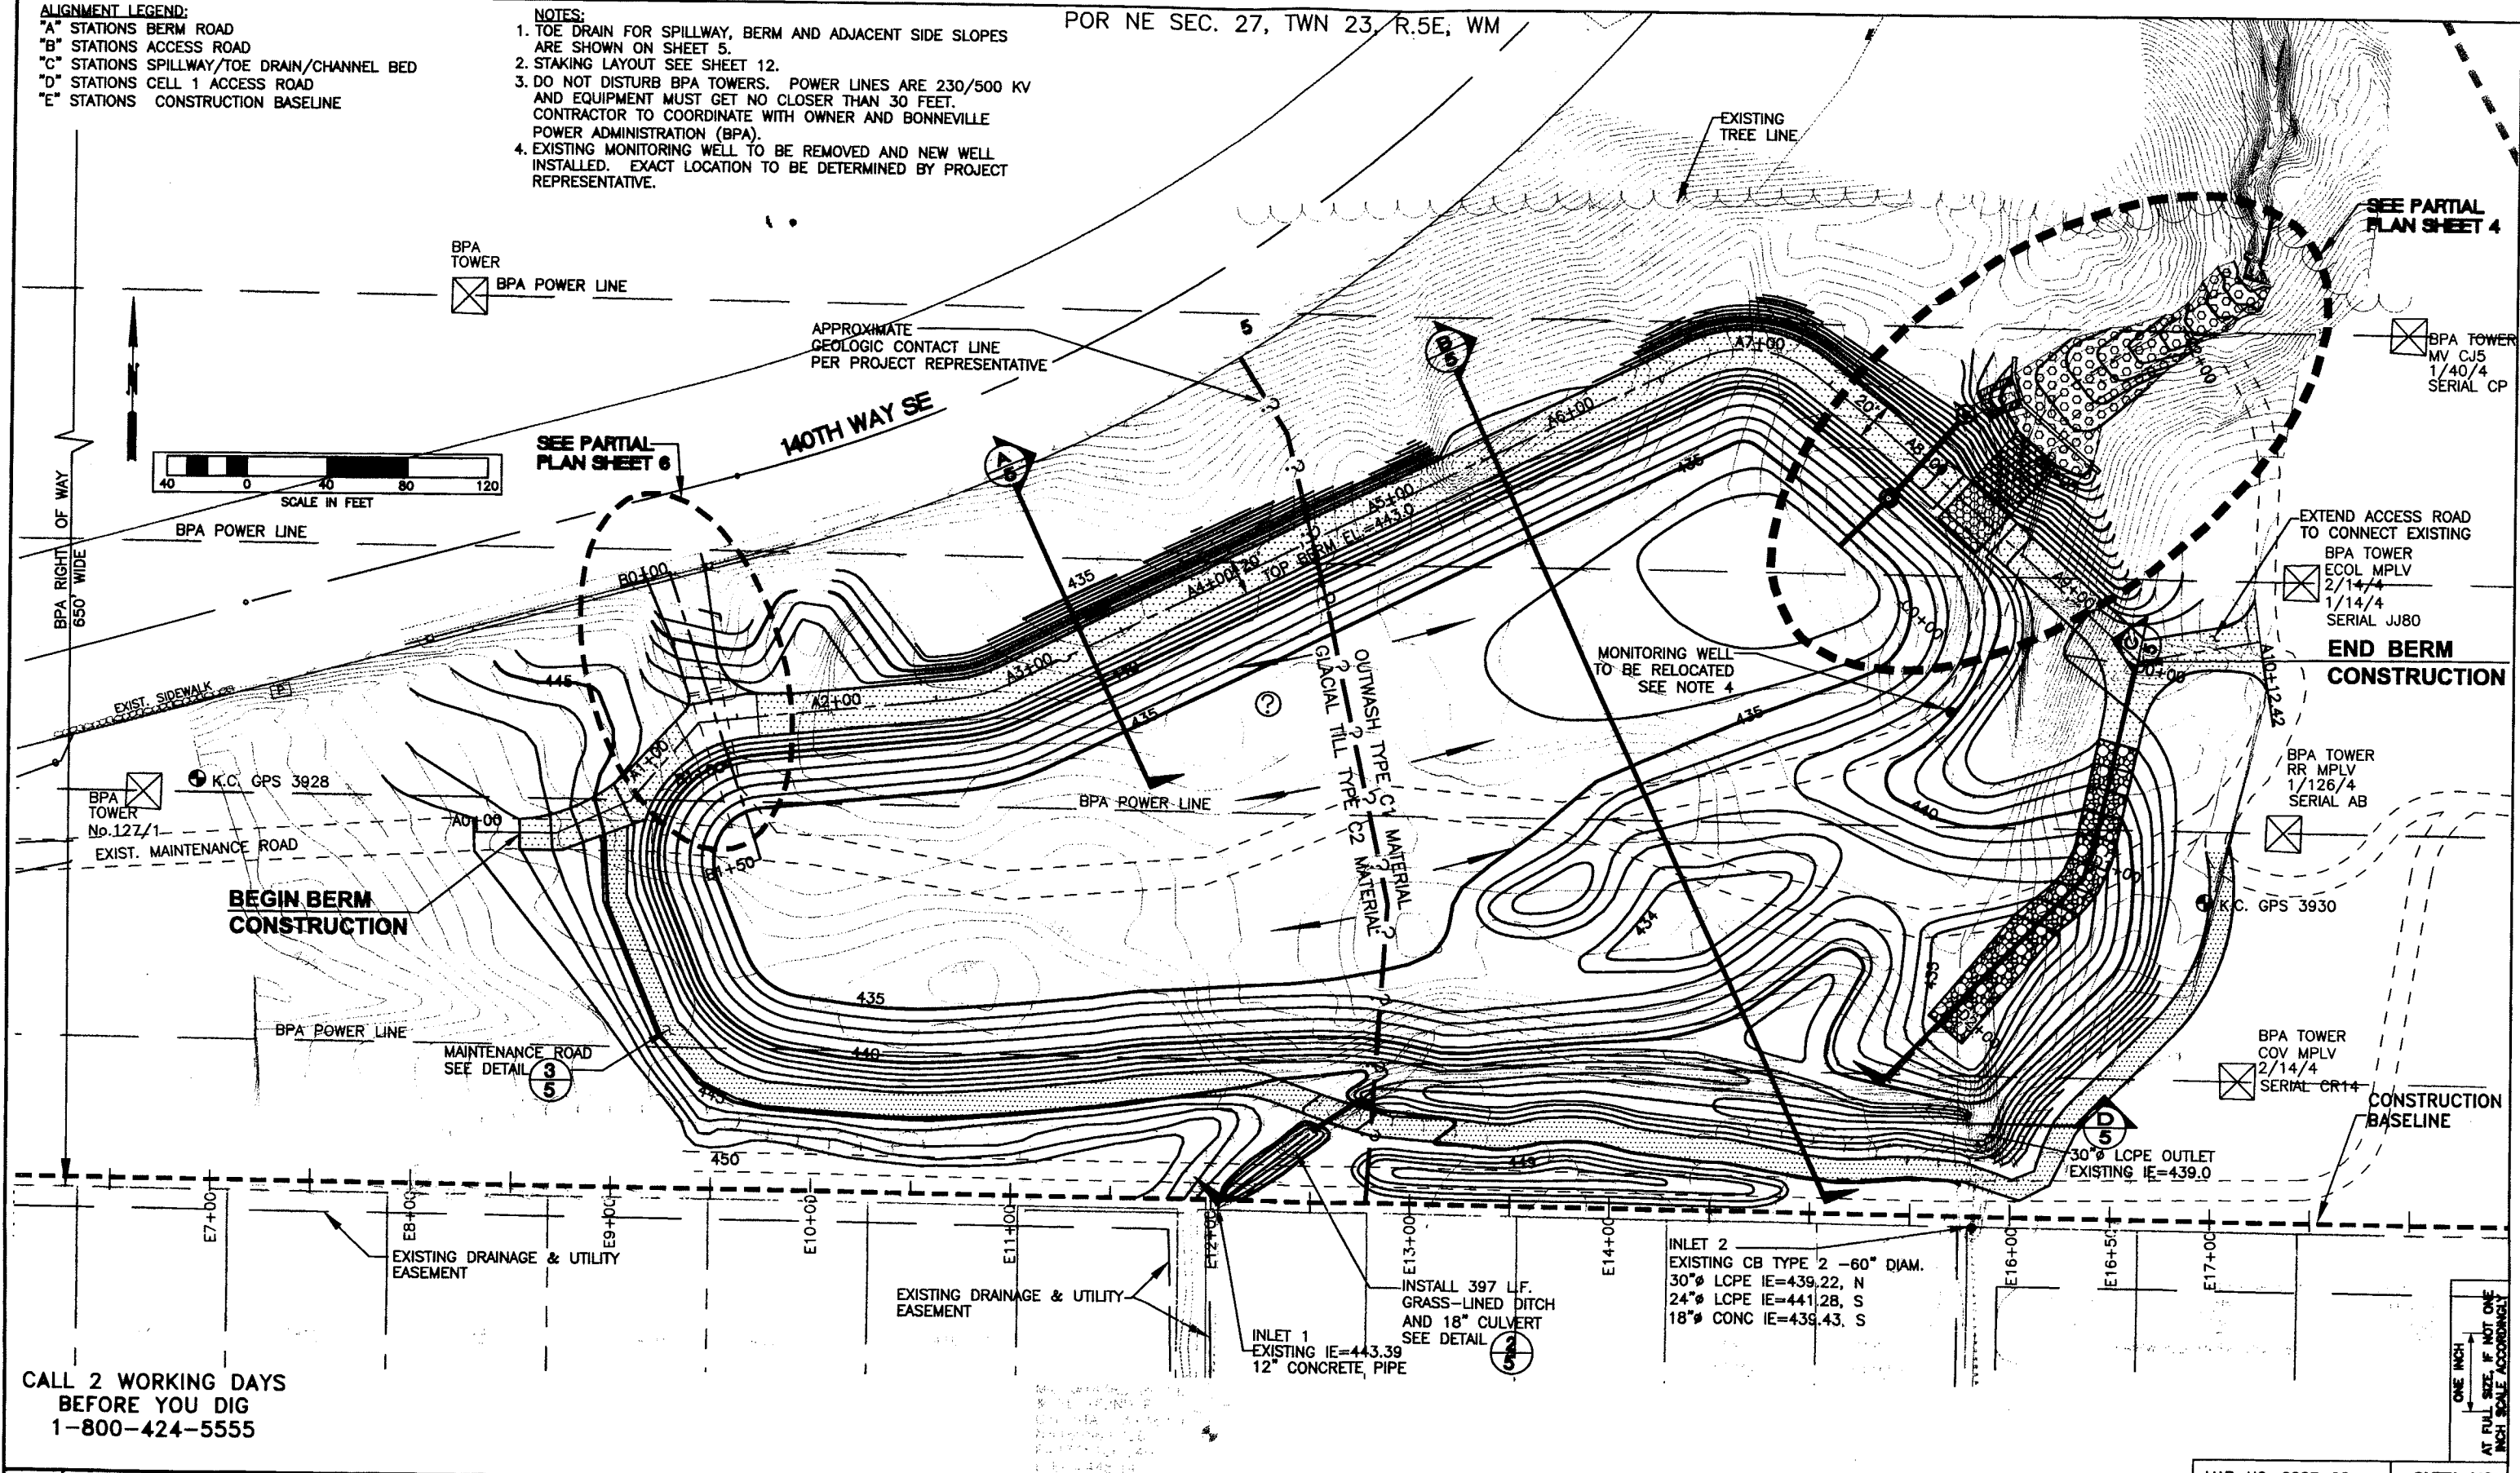
MAP-NO. 2003-92  
 CNTRL-NO  
 DATE: APRIL 2005  
 FILE NO:  
 DRAWING NO: C2  
 SHEET NO: OF 3

DEPARTMENT OF NATURAL RESOURCES AND PARKS  
 WATER AND LAND RESOURCES DIVISION  
**MADSEN CREEK**  
**WEST BASIN WATER QUALITY IMPROVEMENT**  
**POND GRADING PLAN**

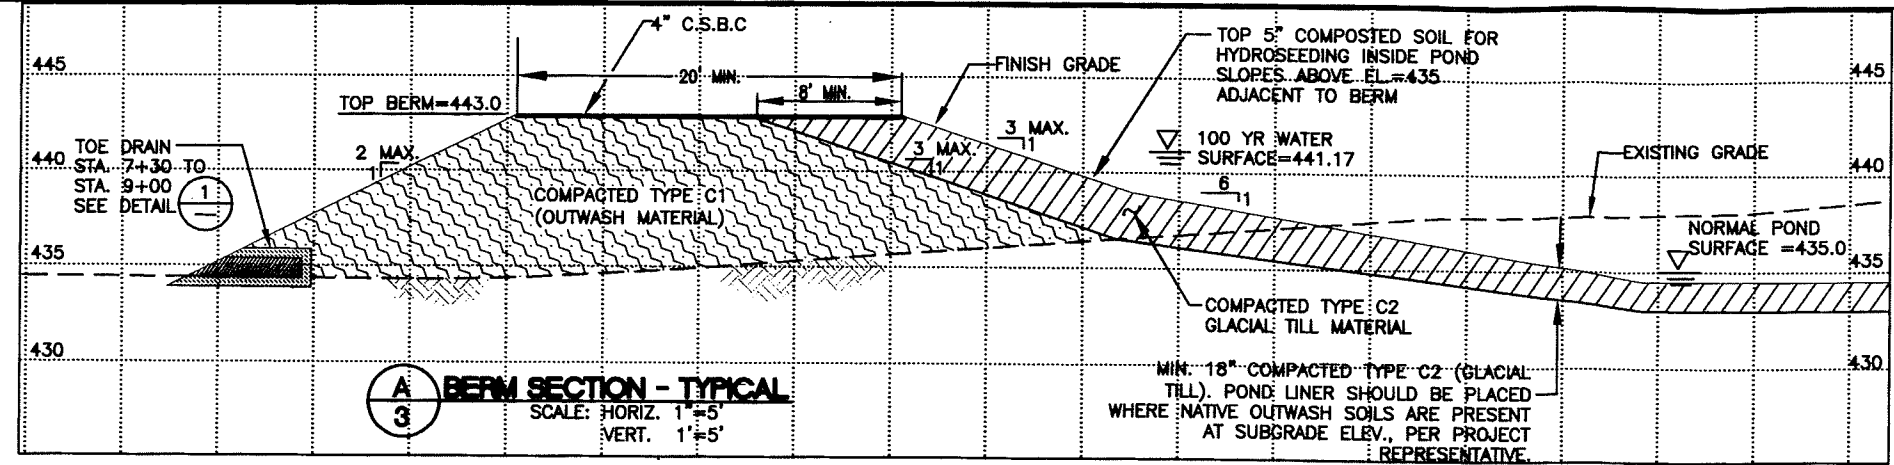
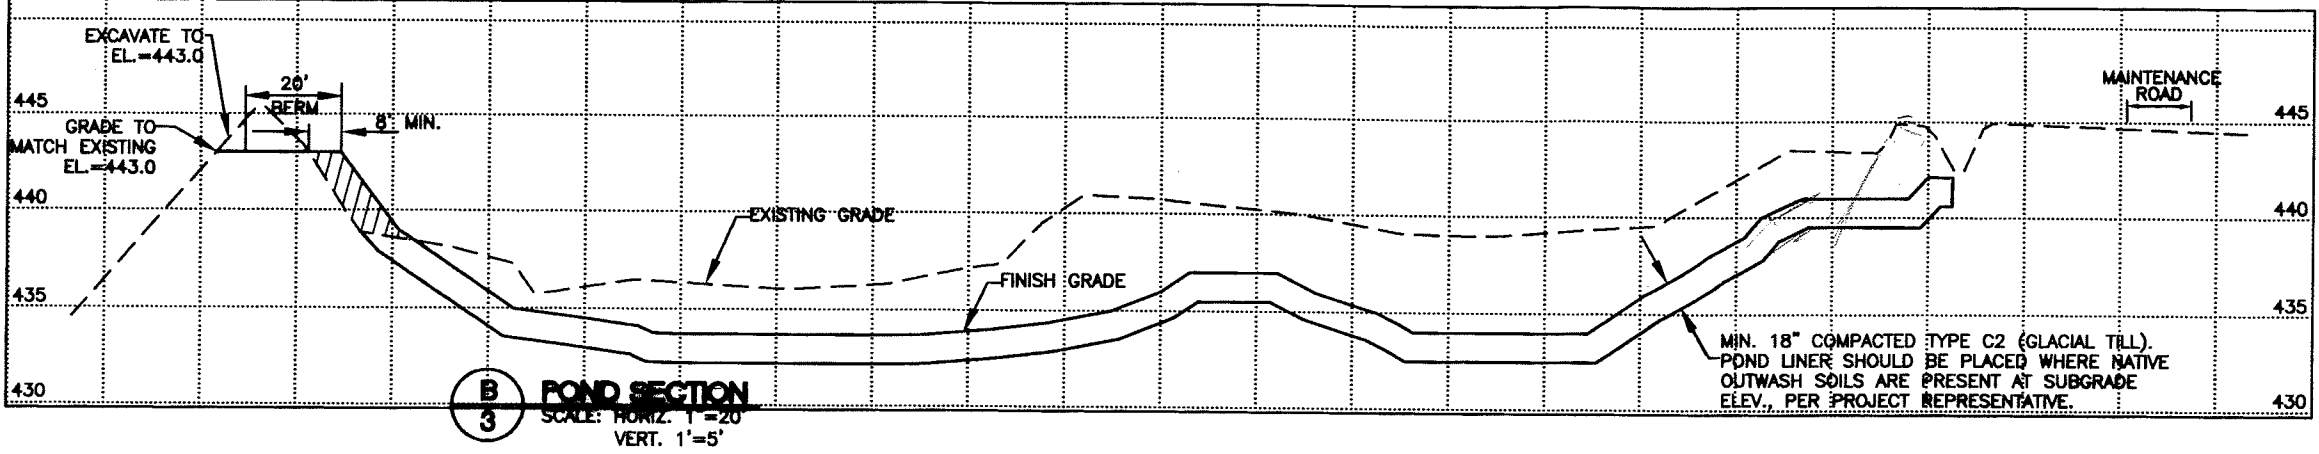
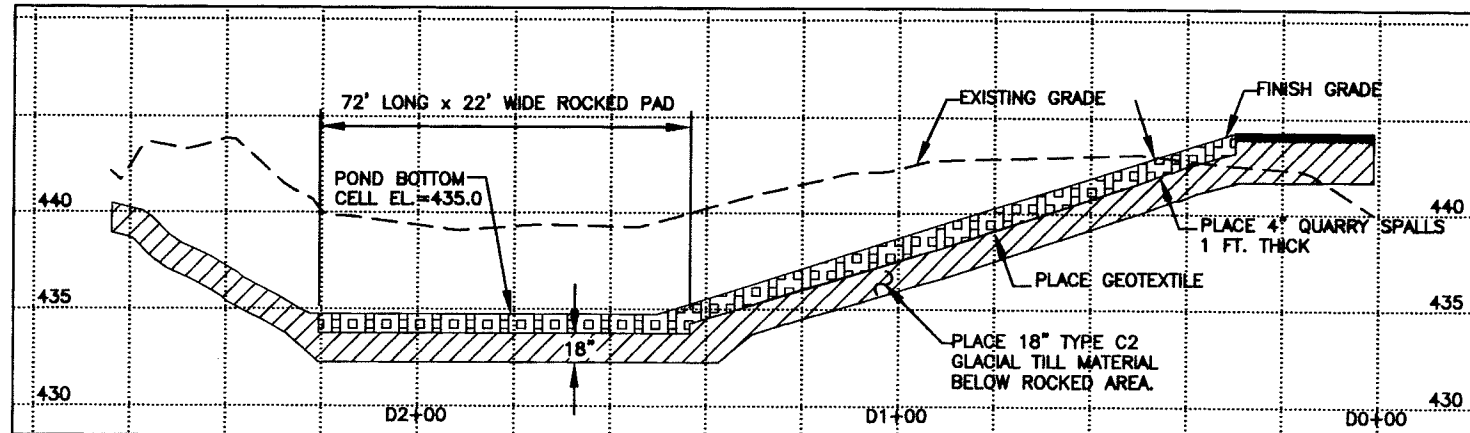
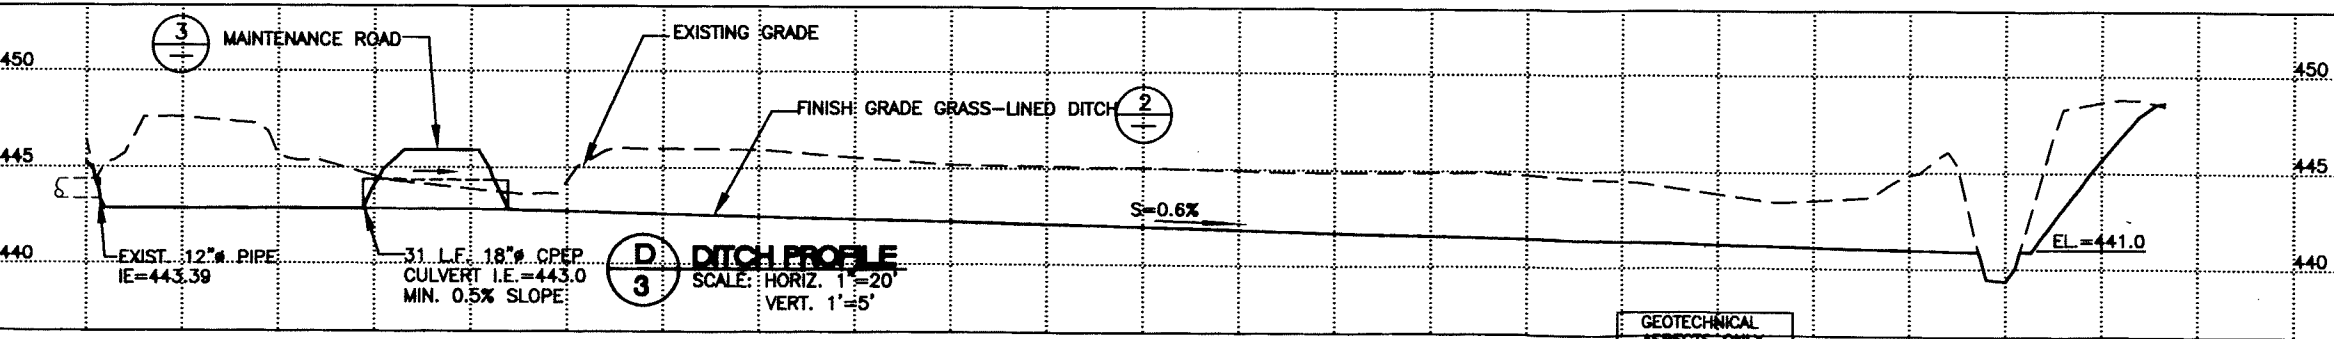
DRAWING NO:  
C4

- NOTES:**
1. EMBANKMENT FOUNDATION AND POND AREA SHALL BE VISUALLY OBSERVED AND APPROVED BY PROJECT REPRESENTATIVE PRIOR TO EMBANKMENT AND LINER CONSTRUCTION. PER SPECIFICATION SECTION 2200-3.01-B.
  2. BERM LIFT COMPACTION SHALL BE OBSERVED BY PROJECT REPRESENTATIVE.
  3. PROVIDE TOE DRAIN BETWEEN STA. A7+30 AND A9+00.
  4. WHEN SPRINGS OR WET AREAS ARE FOUND AND BETWEEN STA. A2+50 AND A7+30, A LAYER OF FILTER 1 MATERIAL WILL BE REQUIRED BELOW THE EMBANKMENT FILL AS DIRECTED BY THE PROJECT REPRESENTATIVE.
  5. BENCHING REQUIRED TO KEY EMBANKMENT INTO SLOPE AS SPECIFIED BY THE PROJECT REPRESENTATIVE.

Toe Drain	Annually or during large storms	Toe drain from Station 7+30 to 9+00. Inspect for, and repair, any slumping, erosion, and other visual deformation along toe (see “Erosion Control on Downstream Face”). Report any toe drain discharge to the Supervising Engineer for dam operation.
Seepage	Annually or during large storms	Report any seepage to the Supervising Engineer for dam operation for additional evaluation. Record seepage locations and quantities at the downstream toe, the berm embankment face, the downstream abutment, and downslope of the toe. Inspect for wet and/or soft areas, or other evidence of seepage forming. Record on Data Form in Appendix D.
<b>Pond Liner</b>		
Low Permeable Clay Liner	Annually  Or  Following large storm and seismic events	Where possible, inspect integrity of liner, especially following large storm events and seismic events, including detailed observations of any slumps and cracks.  Liner material that has slumped or cracked should be regraded and cracks sealed. Possible repair strategies include pouring or placing a soil-bentonite slurry or mud in cracks, or sealing compromised areas with soil blended with bentonite or acceptable low permeable materials. Repair should be coordinated with the Supervising Engineer in charge of dam operation and King County Road Maintenance Services, Materials Lab personnel.

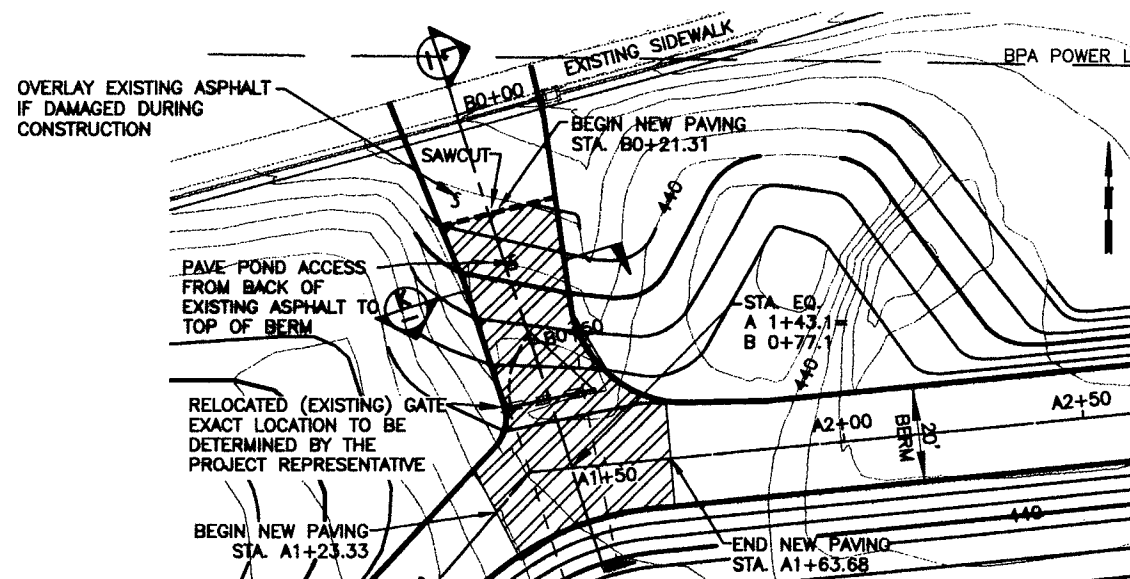
**POND ACCESS ROAD ENTRANCE @ 140TH WAY SE - PARTIAL PLAN**  
STA. B 0+00 TO B 1+24  
SCALE: 1"=20'

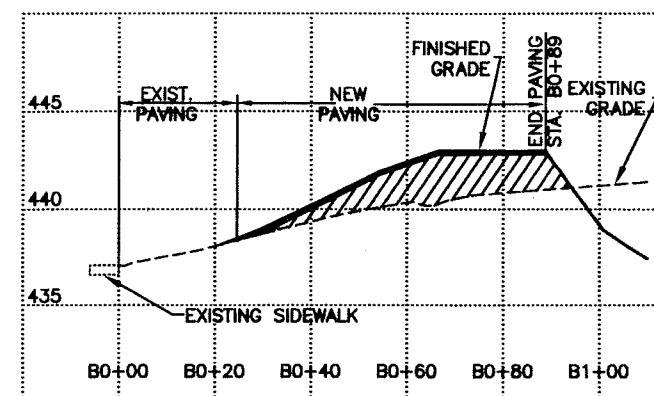
**L ACCESS ROAD - SECTION**  
HORIZONTAL SCALE: 1"=20'  
VERTICAL SCALE: 1"=5'

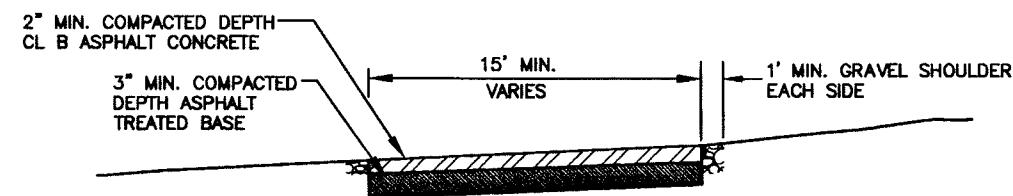
**K PAVING SECTION - TYP.**  
NOT TO SCALE

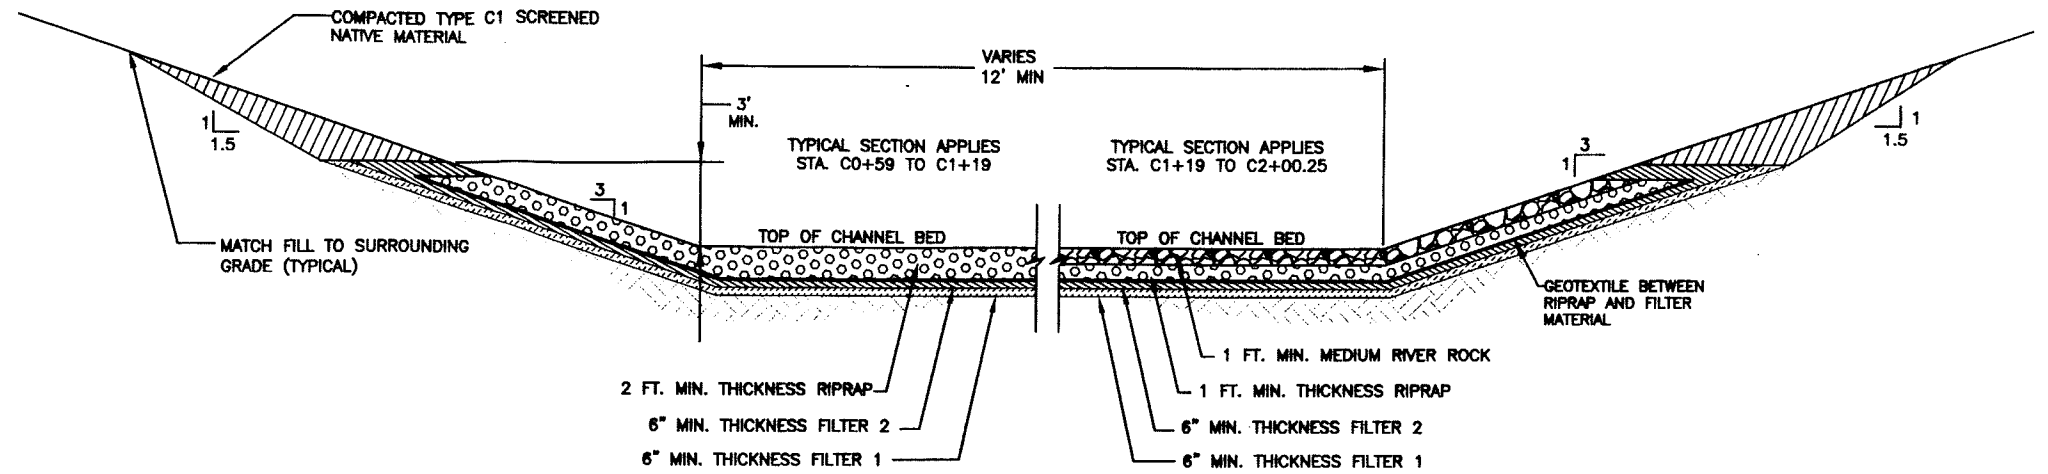
**H** TYPICAL CHANNEL SECTION  
NOT TO SCALE

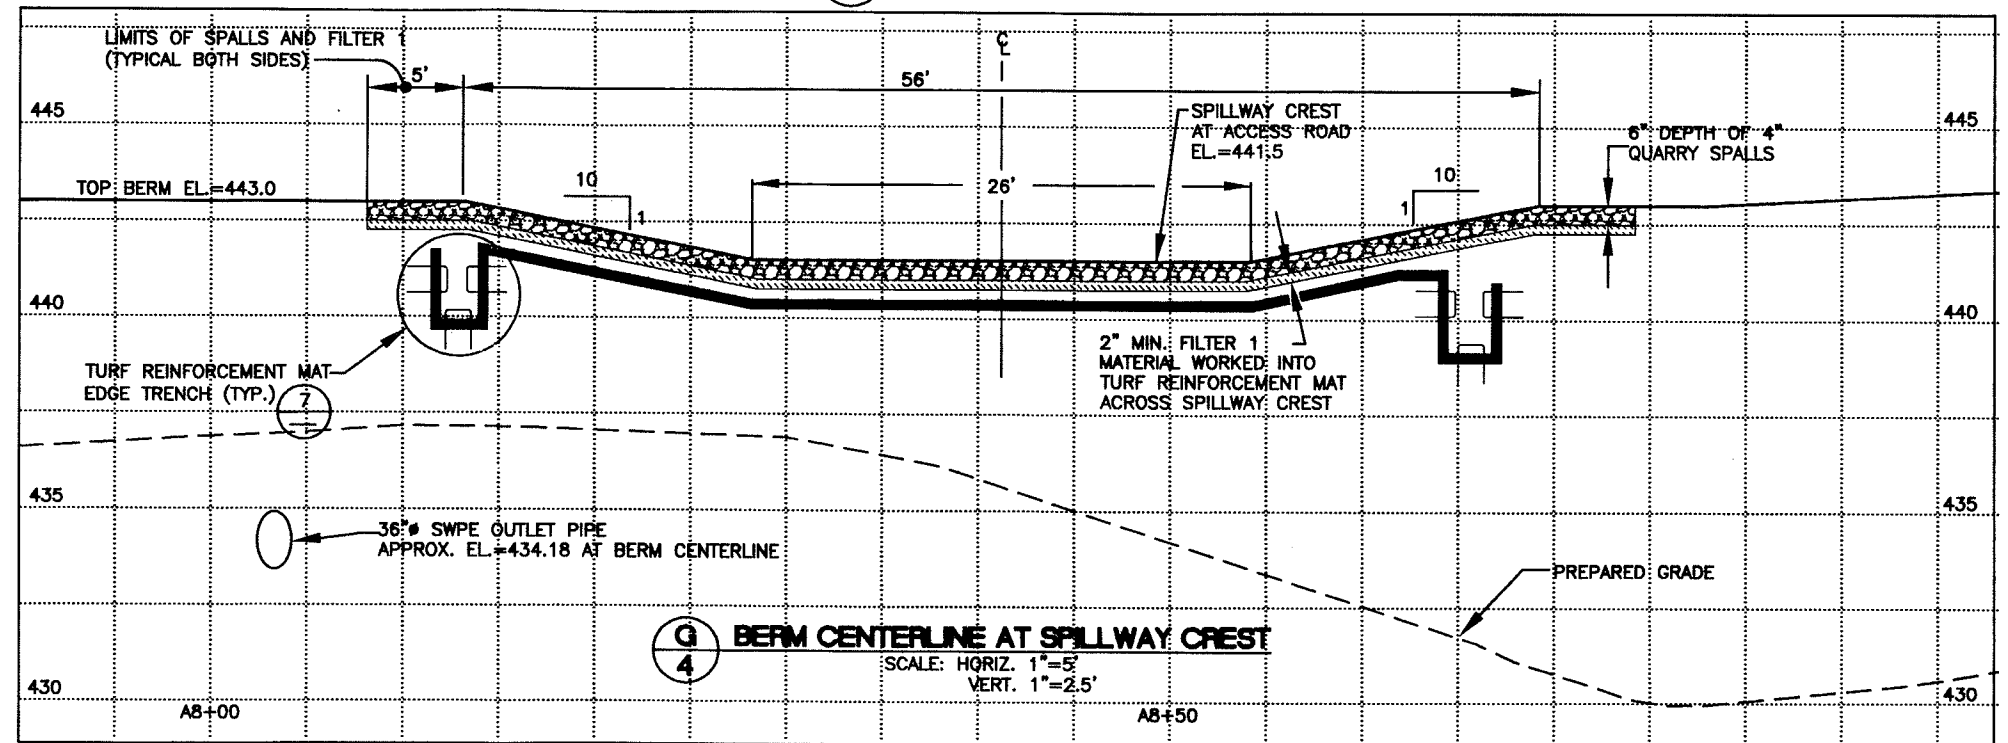
**G** BERM CENTERLINE AT SPILLWAY CREST  
SCALE: HORIZ. 1"=5'  
VERT. 1"=2.5'

Collect elevation measurements along the top of the crest at 50-foot intervals. Extend the measurements at least 150 feet to the northwest of the spillway and 100 feet to the southeast of the spillway (along the embankment centerline). Measurements should also be collected at observed areas of obvious settlement. The elevation of the top of the berm should be approximately 443.00.

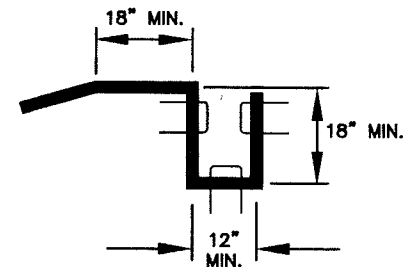
**7** TURF REINFORCEMENT MAT - EDGE TRENCH (TYP.)  
NOT TO SCALE

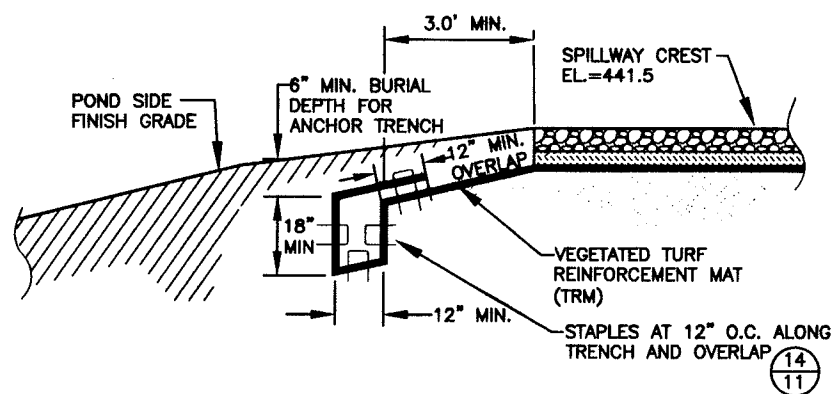
**6** TURF REINFORCEMENT MAT - ANCHOR DETAIL  
NOT TO SCALE

NOTE:  
REFER TO SHEET 11 TURF REINFORCEMENT MAT AND STAPLE  
PATTERN GUIDE DETAILS FOR INSTALLATION DETAILS.

Element	Frequency	Description
<b>Spillway Channel</b>		
Erosion Control	Annually & after floods	Turf Reinforcement Mat (TRM) is to be repaired/replaced in accordance with the specifications in Appendix C. In addition, for acceptable replacement TRM products, refer to Appendix C.  Grass should be added as appropriate to the damaged area to prevent future erosion.
Spillway Channel	Annually	Remove any obstructions or debris from the spillway channel.
Energy Dissipater (Type II Catch Basin)	Annually	Remove visible obstructions.
Gabion Baskets	Annually	Replace rock and repair gabion baskets, which have been vandalized. Reinforce gabion baskets with concrete slurry if wire basket has corroded.
<b>Inlet/Outlet Works</b>		
HDPE Conduits	Annually	Inspect conduit for leakage or other significant problems (see “Seepage”).  Inspect entire conduit interior either manually or via remote control camera as needed. Repair or reline as needed.

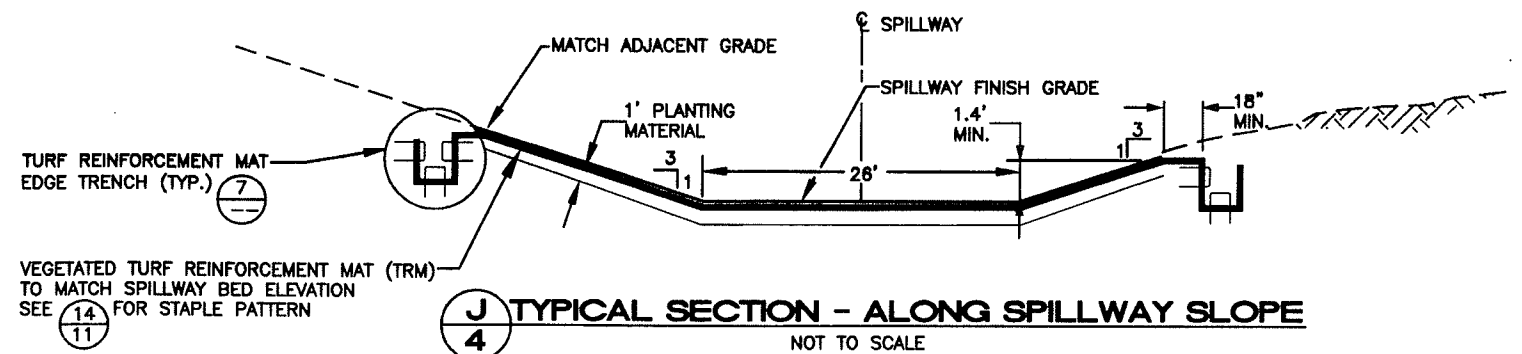
**J** TYPICAL SECTION - ALONG SPILLWAY SLOPE  
NOT TO SCALE

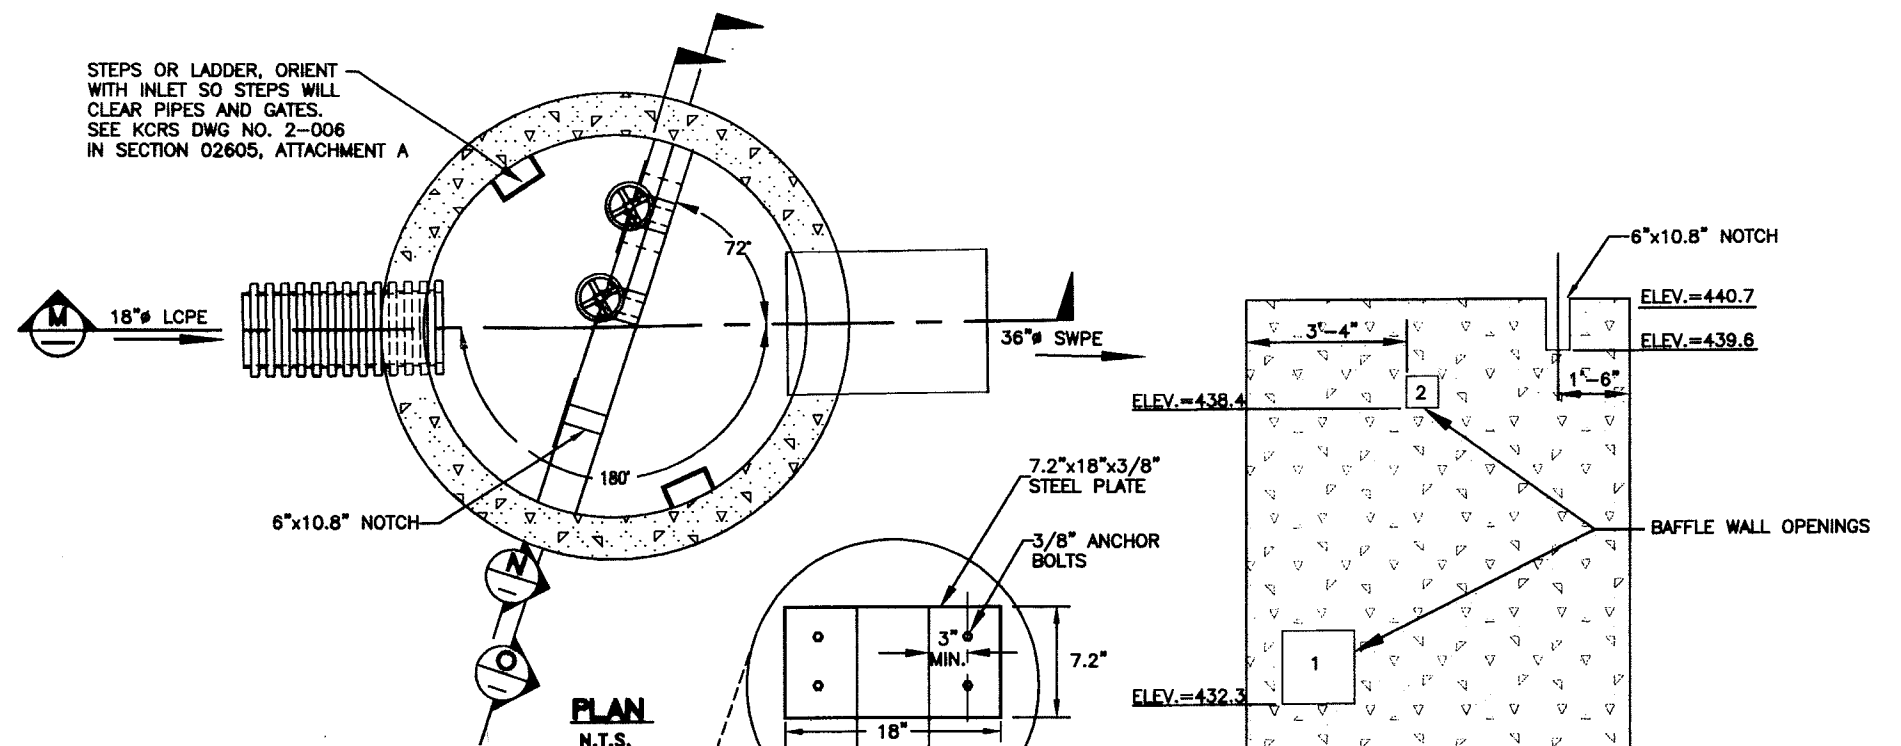
**BAFFLE SECTION**  
SCALE 1" = 2'

OPENING NO.	WIDTH	HEIGHT	BOTTOM GATE ELEV.
1	18"	18"	432.3
2	8"	8"	438.4
3 (NOTCH)	6"	4.8"	439.6

- NOTES: 1. INSTALL SELF-CONTAINED CAST IRON SLUICE GATES W/NON-RISING STEMS. MOUNT VERTICALLY W/CAST IRON WALL THIMBLES AND WEDGES. USE BRONZE ASTM B584 THRUST NUT AND ASTM A276, TYPE 304 STAINLESS STEEL ASSEMBLY AND ANCHOR BOLTS
2. BAFFLE SECTION MEASUREMENTS ARE TAKEN FROM THE INSIDE OF THE MANHOLE.
3. BAFFLE AND CATCH BASIN REINFORCEMENT TO BE DETERMINED BY SUPPLIER.
4. NORMAL OPERATION OF GATE OPENINGS:  
GATE 1: OPENING 0.12'  
BOTTOM EL.=432.67  
TOP EL.=433.12  
GATE 2: OPENING 0.50'  
BOTTOM EL.=438.4  
TOP EL.=438.86  
PLATE ATTACHED TO NOTCH:  
OPENING 0.46'  
BOTTOM EL.=439.6  
TOP EL.=440.70  
PLATE IS MEASURED AT 18"W x 7.2"H

Two sluice gates are installed in the facility's 96-inch, Type II catch basin located on the upstream side of the berm. This control structure contains a baffle wall and is topped by a bird cage overflow structure. The sluice gates and a plate are installed on the concrete baffle wall. The gates and plate are used to regulate flow and are set at a designated opening height/elevation to release flows as listed above in Table 1. Normal operating conditions are summarized in Table 2.

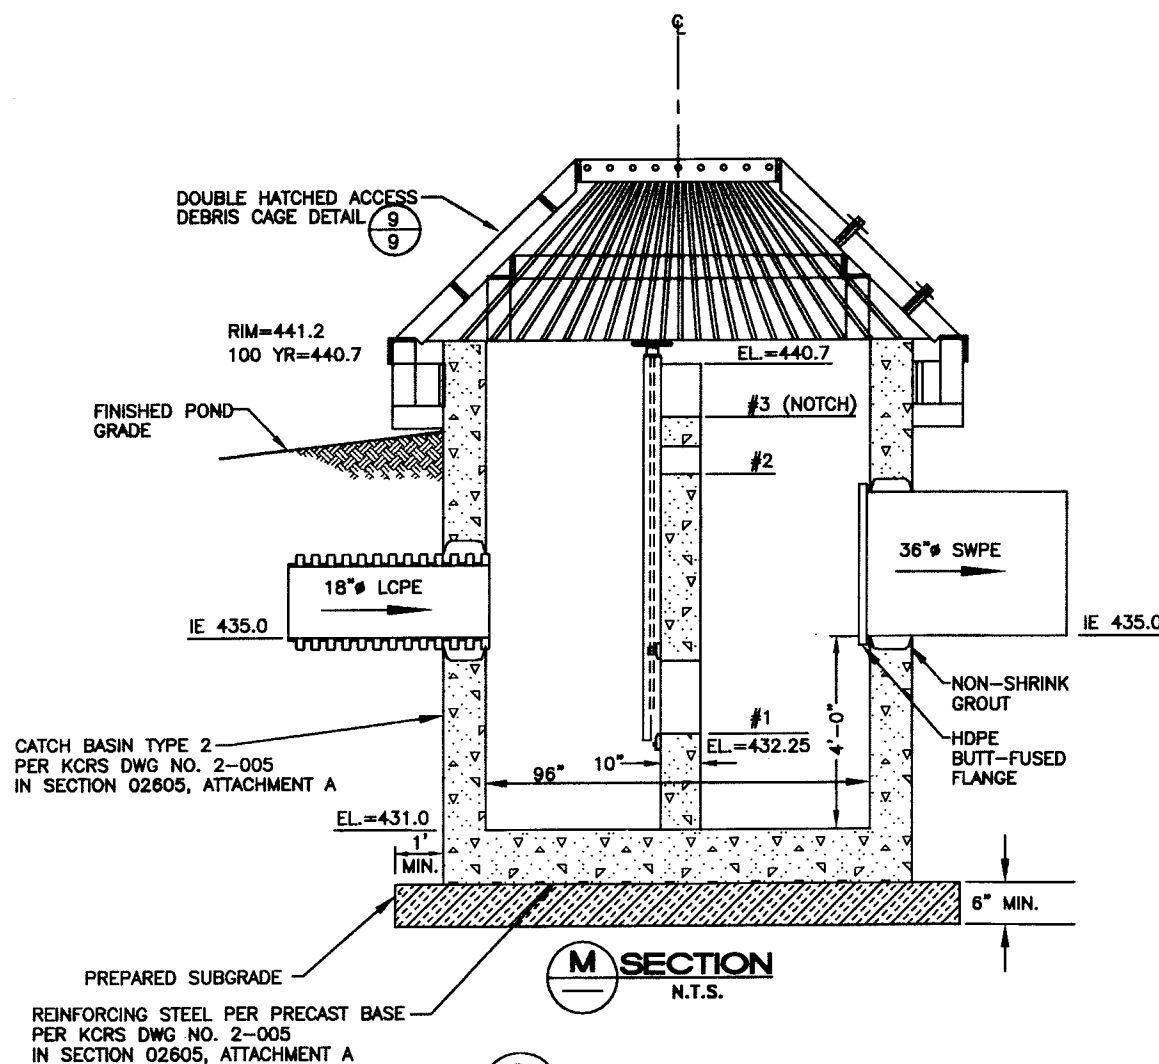
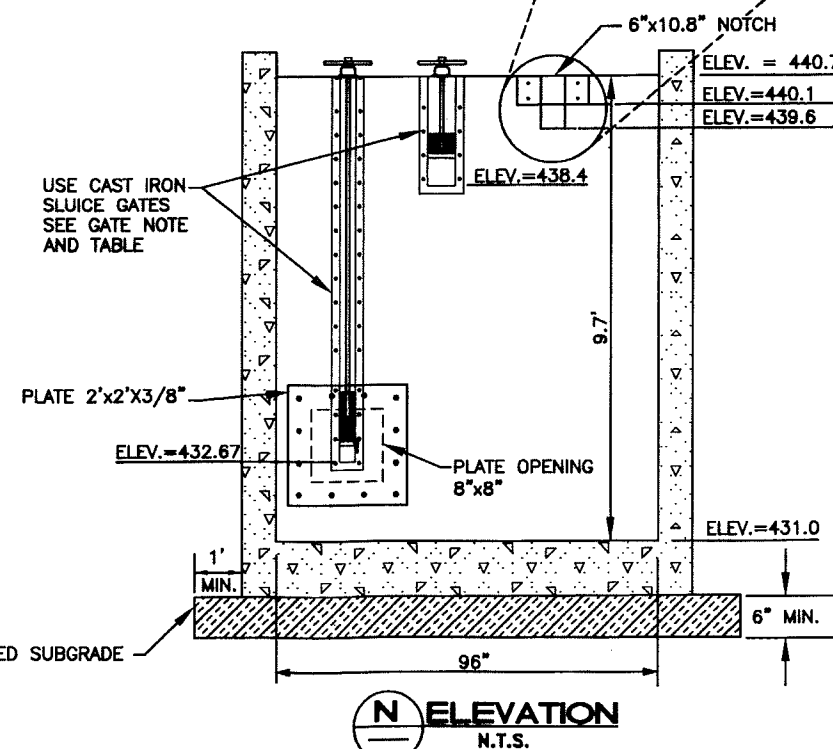
**8 96"± COMBINED OVERFLOW AND FLOW CONTROL STRUCTURE**  
412 SCALE 1" = 2'

*Emergency operation or opening of the lower sluice gate is required when lowering of the pond's water surface elevation is necessary to relieve hydrostatic pressure on the dam, such as during a potential piping failure of the embankment. The gate should be fully opened and reservoir drained as quickly as possible as Madsen Creek (Northwest Tributary) will allow.*

*Emergency operation of the upper sluice gate is NOT recommended during dangerously high water surface levels. The primary outflow pipe will likely already be flowing at maximum capacity and opening the slide gate will not increase discharge.*

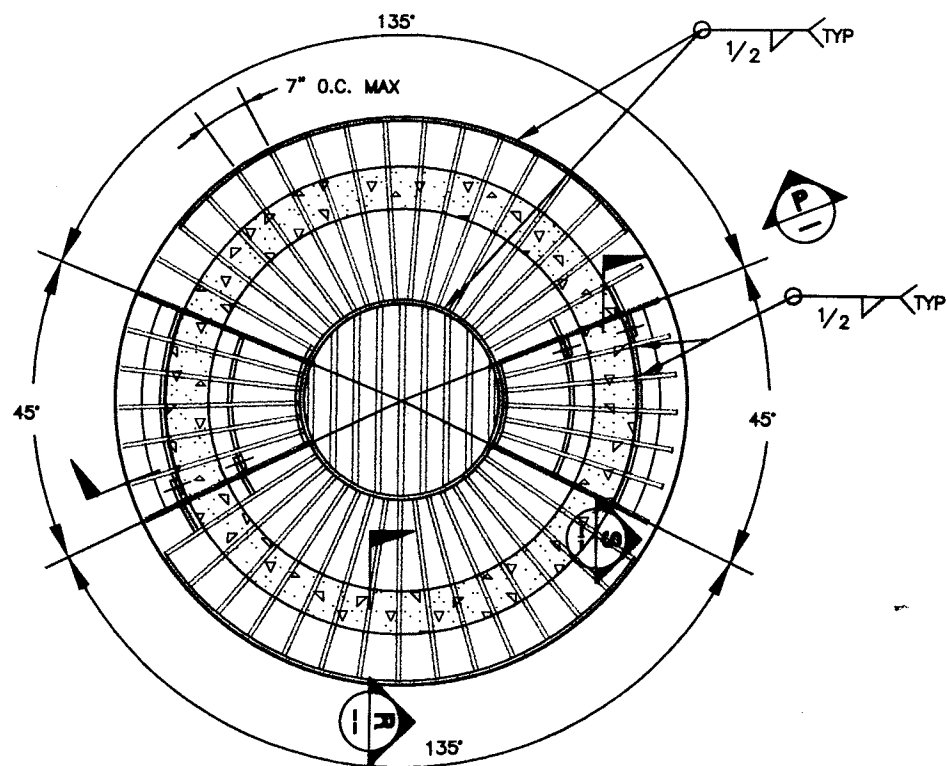
**DEBRIS CAGE PLAN** (9/8)  
N.T.S.

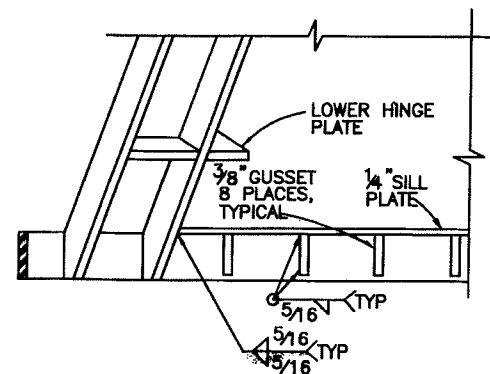
**SECTION S**  
HATCH REMOVED  
N.T.S.

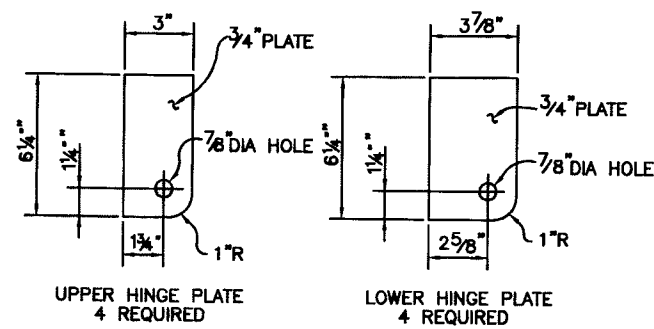
**DETAIL 11**  
N.T.S.

NOTE: LOCATE HINGE PLATES PARALLEL TO EACH OTHER AND PERPENDICULAR TO HINGE CENTERLINE. SEE DETAIL FOR HINGE PLATES (11)

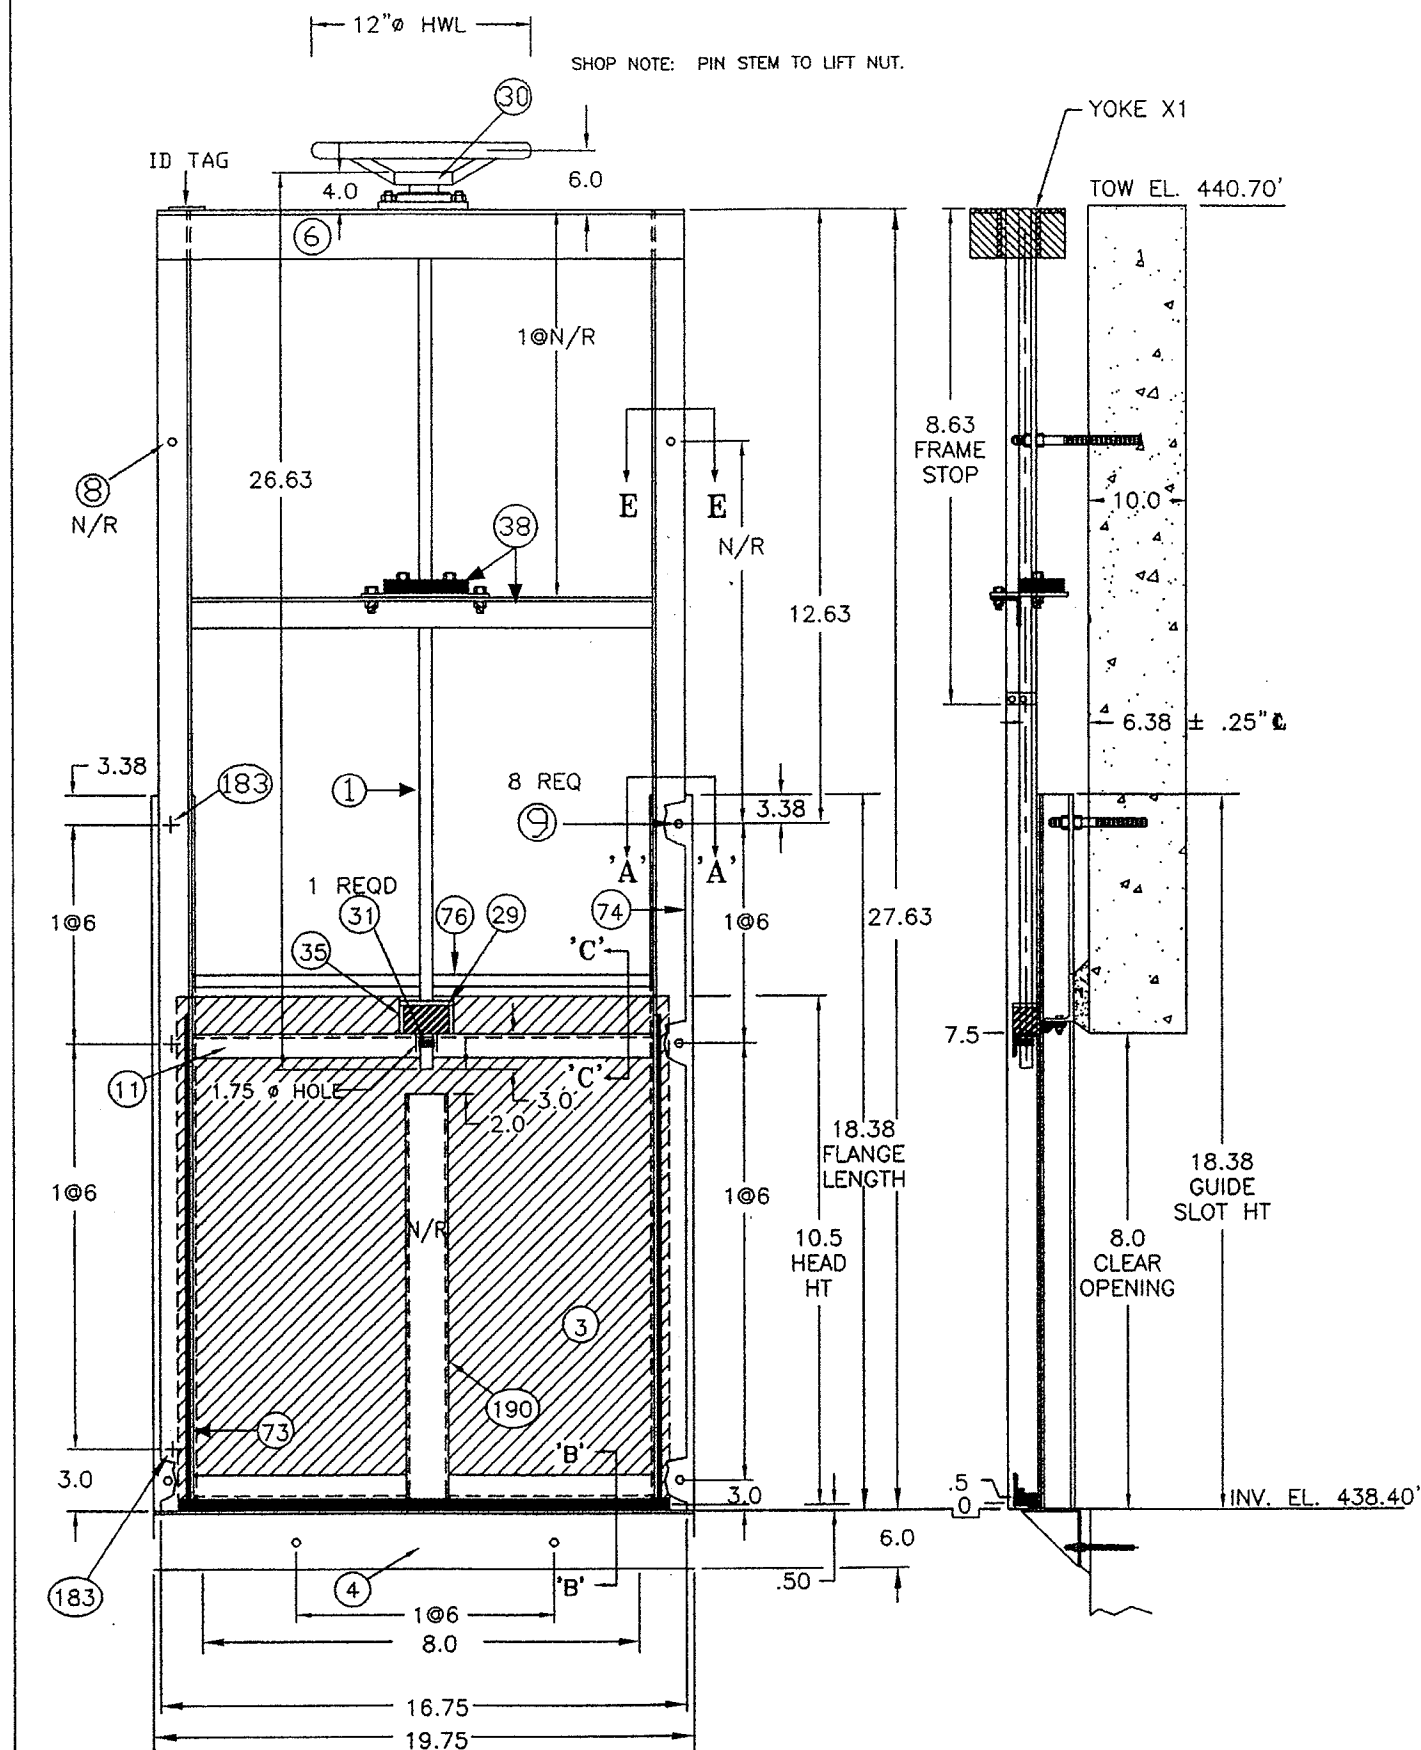
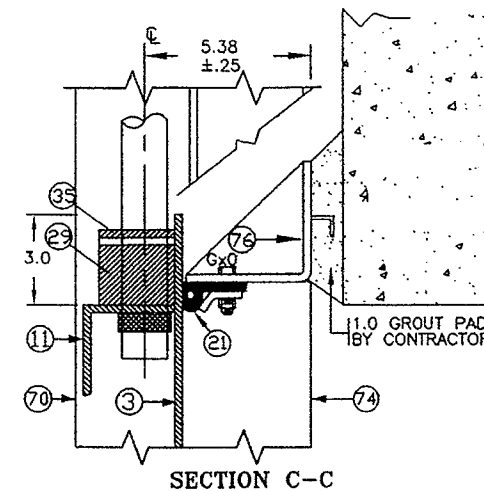
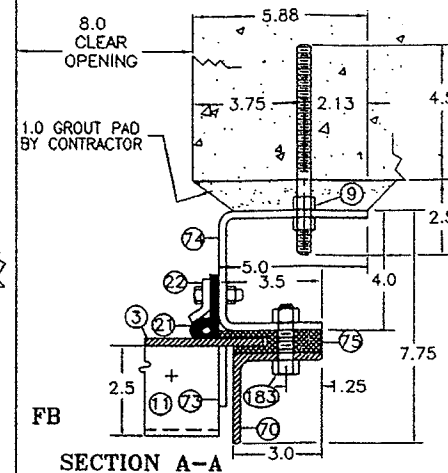
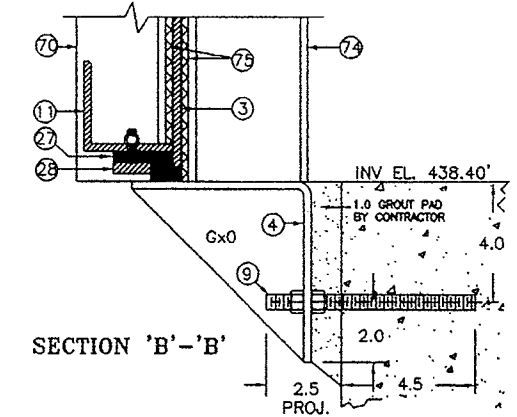
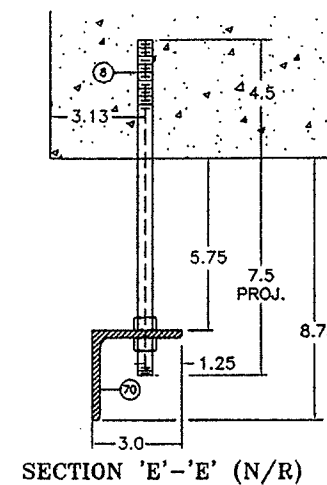
MD GH-46 STAINLESS STEEL SLUICE GATE MATERIAL LIST		
1	STEM	1" DIAMETER S-STL, W/L HAND ACME ROLLED THREADS, 16 MICRO IN. RMS OR LESS FINISH
3	GATE HEAD	1/4" S-STL PLATE
4	INV. MEMBER	6.0x6.0x1/4" FORMED S-STL ANGLE
6	YOKE	4.0 x 4.0 x 1/4" FORMED S-STL ANGLE
8	ANCHOR BLT	1/2x12.0 S-STL ANCHOR ROD, W/2 NUTS
9	ANCHOR BLT	1/2x7.0 S-STL ANCHOR ROD, W/2 NUTS
11	STIFFENER	1/4x2.5 S-STL FLAT BAR
21	P-BULB SEAL	NEOPRENE RUBBER
22	RETAINER	3/16" X 2" S-STL FLAT BAR, W/SLOTTED HOLES
27	INVERT SEAL	NEOPRENE RUBBER, PART# 7509
28	INV. SEAL RTNR	3/8" X 1 1/4" S-STL FLAT BAR
29	NRS STEM NUT	2.5x2.5x2.0 SQ BRONZE
30	OPERATOR	GH-1, NON-GEARED, HANDWHEEL, ANODIZED ALUMINUM HOUSING, MECH. SEALS ROLLER BEARING SUPPORTED BRONZE LIFT NUT, GREASE ZERK, OPEN DIRECTION ARROW
31	STOP NUTS	BRONZE
35	STEM POCKET	1/4" S-STL FLAT BAR
38	STEM GUIDE	2.0x2.0x1/4" S-STL ANGLE W/UHMW STEM GUIDE BUSHING
70	GUIDE RAIL	3.0x3.0x1/4" HR S-STL ANGLE

73	VERT. STIFF.	1/4" x 2.0 S-STL FLAT BAR
74	VERT. SPIGOT RAIL	5" x 4" x 3.5" x 1/4" FORMED S-STL CHANNEL
75	GUIDE BEARING BAR	UHMW POLYETHYLENE
76	HORIZONTAL SPIGOT	4 1/8" x 4" x 1/4" FORMED S-STL ANGLE
183	CLAMP BLT	1/2" x 2" S-STL HEX BOLT, W/NUT & F/W
190	VERTICAL STIFFENER N/R	3.0x2.5x2.5 FORMED CHANNEL

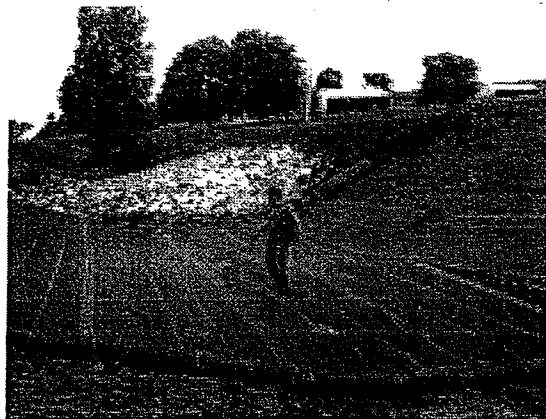
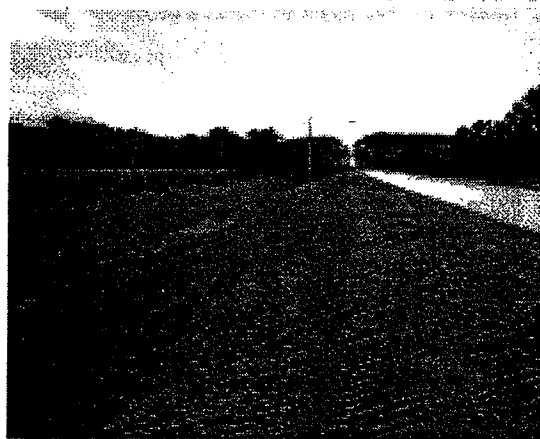
The C350's coconut fibers also functioned as an excellent mulch material and resulted in more rapid vegetation establishment in the channel. Budgeting constraints required that only the bottom and portions of the side slopes of the channel be covered by C350. Comparison of unprotected areas of the channel and those portions where C350 had been installed revealed that the C350 promoted a denser stand of vegetation and a more rapid rate of vegetation establishment (see Photo 3).

The C350 was installed immediately after channel construction activities (see Photo 1) and was partially vegetated when a number of massive storm events resulted in numerous high discharge flow events taking place in the channel prior to vegetation establishment. The C350 reinforced immature vegetation provided effective erosion protection for this channel as was apparent when the flows dissipated and there were no visible signs of soil loss or rilling under the matting (see Photo 2).

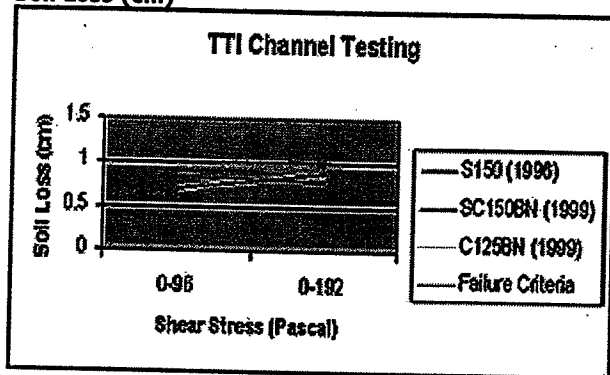
Soil Loss (cm)

### Channel Test Data from the Texas Transportation Institute (TTI) for North American Green Erosion Control Blankets.

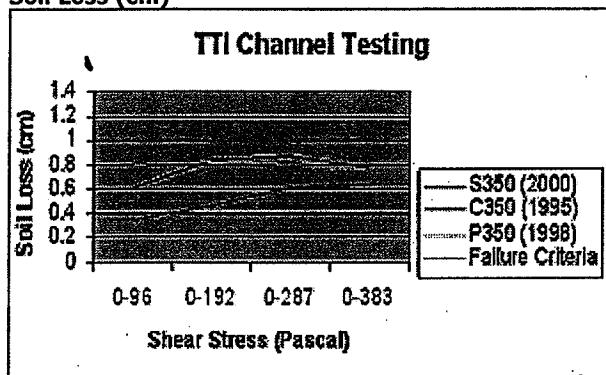
**Soil Loss (cm)**

Channel Test Data from the Texas Transportation Institute (TTI) for North American Green Turf Reinforcement Matting.

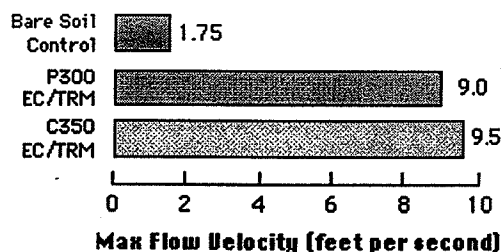
Maximum velocity for unvegetated mattings at 0.5 inch soil loss

Phase 1 is the pre-emergence phase or immediate erosion control provided, consisting of the time period between seed application and seed germination and emergence. This phase requires effective erosion control and mulching to protect the seed and soil and enhance seed germination. Typically, the TRM selected for use will provide the sole means of erosion control during this developmental phase.
